(12) **EUROPEAN PATENT APPLICATION**

(71) Applicant: **GENERAL ELECTRIC COMPANY**
Schenectady, NY 12345 (US)

(54) **Repair of high pressure turbine shrouds**

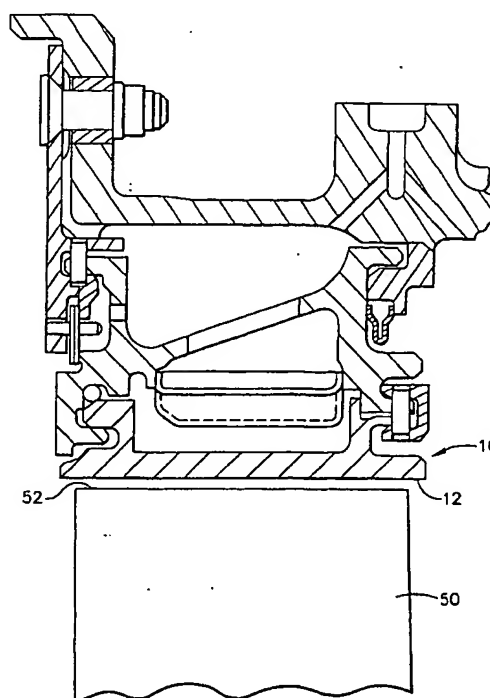
FIG. 1

(57) A method for repairing the shroud surfaces of a gas turbine engine to provide corrosion and oxidation resistance of the shroud segments (10) while also restoring the dimensional integrity of the shroud segments (10). The method entails removing the oxidation and corrosion products from the shroud segment (10), removing preexisting coating materials, applying a material compatible with the shroud segment substrate material, machining the surface, applying a corrosion-resistant, oxidation-resistant and rub-compliant material to the shroud segment using a HVOF process, machining the shroud segment (10) to preselected dimensions and applying an aluminide coating for improved oxidation and corrosion resistance of the repaired surfaces.

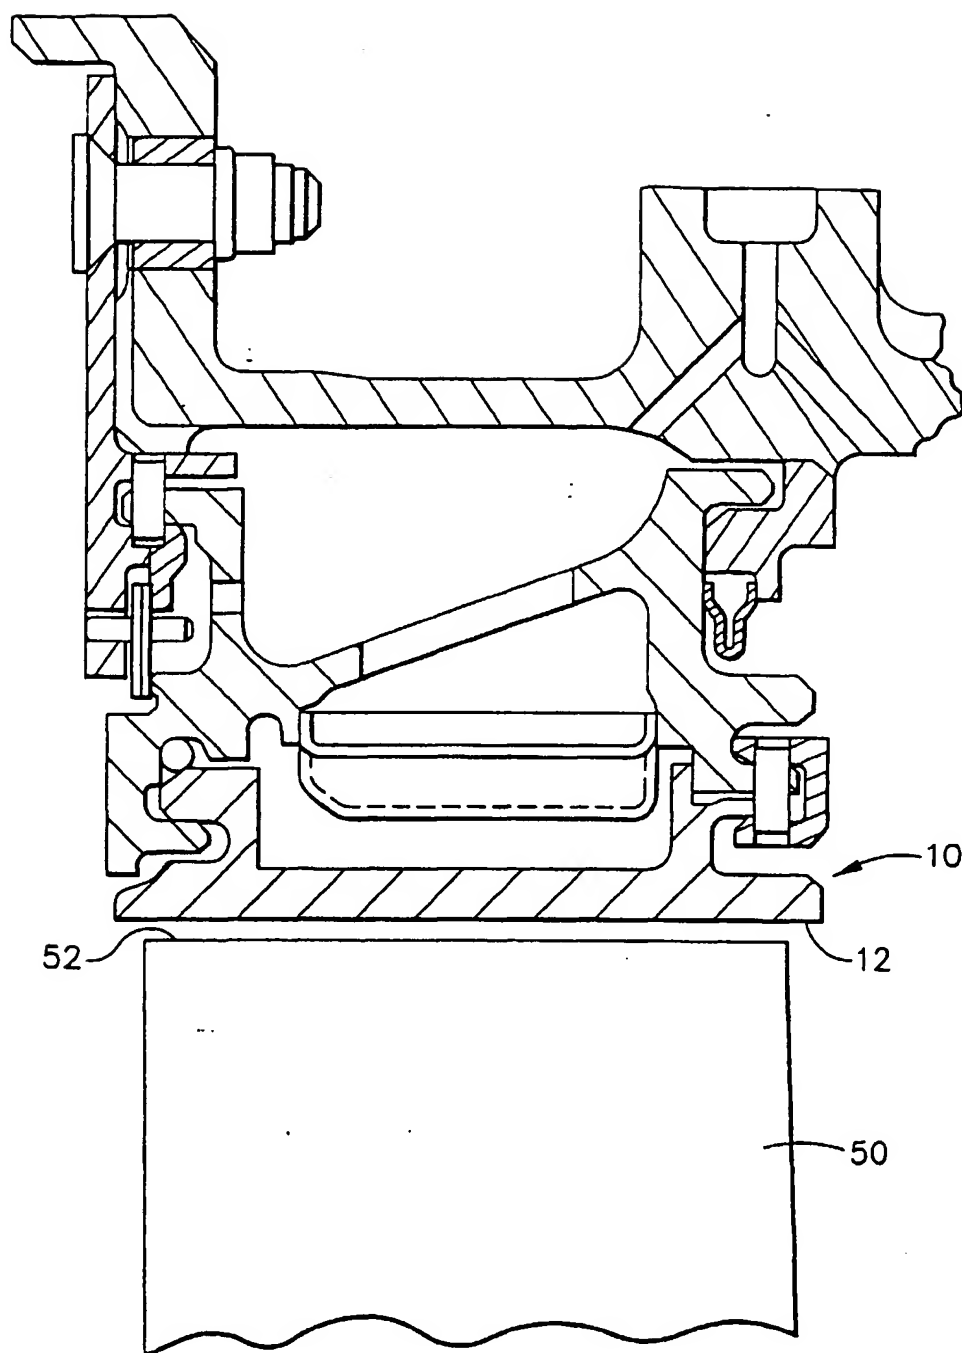
FIG. 1

Fig. 1 is a cross-sectional view of a shroud assembly, showing a shroud segment showing the shroud flow path surface adjacent to the tip of a turbine blade, the shroud support, the shroud hanger support and the support case;

[0010] Fig. 1 is a cross-sectional of a turbine engine shroud assembly, showing shroud segment 10. In this view, the shroud segment 10 has a flow path surface 12. Also shown for illustration purposes is a turbine blade 50 having a tip 52 immediately adjacent to the flow path surface 12 of the shroud segment. Fig. 2 is a perspective view of shroud segment 10 of Fig. 1. The shroud segment has a fore end 14 and an aft end 16. As shown in Fig. 3, a number of shroud segments having sides 18 are assembled together to form a shroud assembly that has the shape of a cylinder surrounding the turbine blades. As the hot gases of combustion move rapidly from the combustors along the interior of the engine and across the shroud flow path surfaces 12 from the fore end 14 of the shroud segments to the aft end 16 of the shroud segments, the turbine blades are rotated. As can be seen, the tighter the tolerance between the shroud segments and the blades, the more efficient the engine will operate, since smaller volumes of gases will escape across the shroud flow path.

[0011] With reference to Fig. 1, turbine blades 50 are designed with tips 52 to cut into the flow path surface 12 of the shroud segments, which generally are comprised of a rub-compliant material. Of course, during the course of engine life, the clearance between the blade 52 and flow path surface 12 will gradually increase just from the operation of the rotating blades against the fixed shroud assemblies at various operating temperatures. Furthermore, as the hot gases of combustion pass along the engine interior across the shroud assembly from the fore rails to the aft rails, mechanical erosion of material from the shroud assemblies will also occur, thus increasing the clearance between the blades and the shroud assembly. Also, the hot gases of combustion contain a number of undesirable by-products which will cause not only oxidation, but also corrosion of the shroud assembly materials. Because the shroud assembly is comprised of a number of shroud segments assembled together to form a ring, as the shroud flow

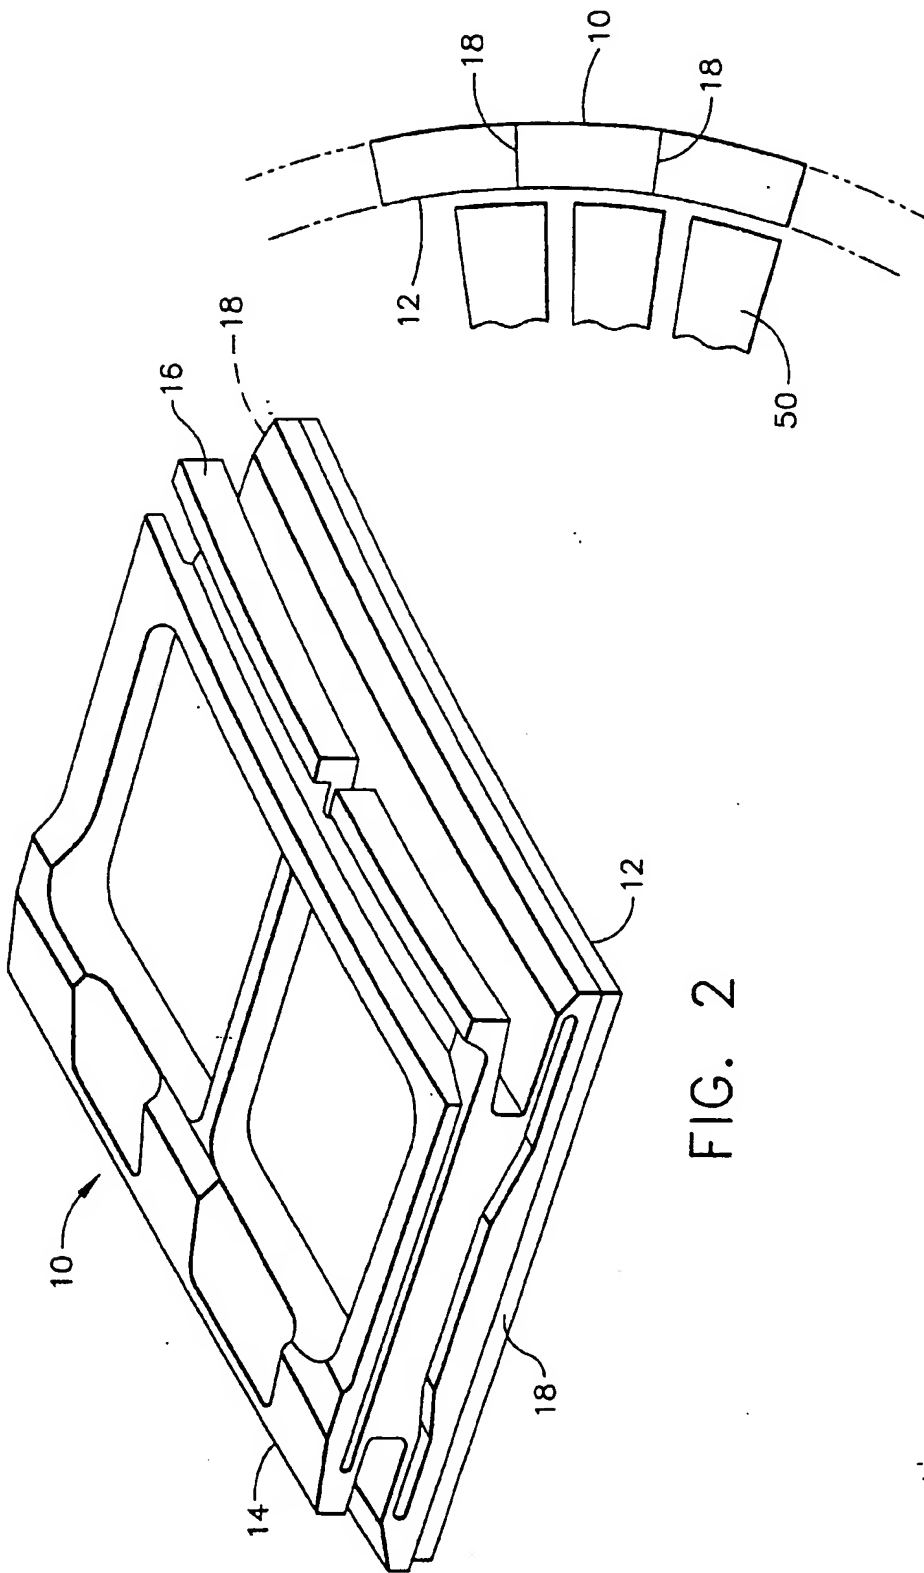
FIG. 2

Fig. 2 is a perspective view of a shroud segment; and

Fig. 3 is a partial perspective view of a shroud assembly, comprises of a series of shroud segments assembled to form a portion of a cylinder around turbine blades.
